Annual Report NPDES Municipal Separate Storm Sewer System Permit

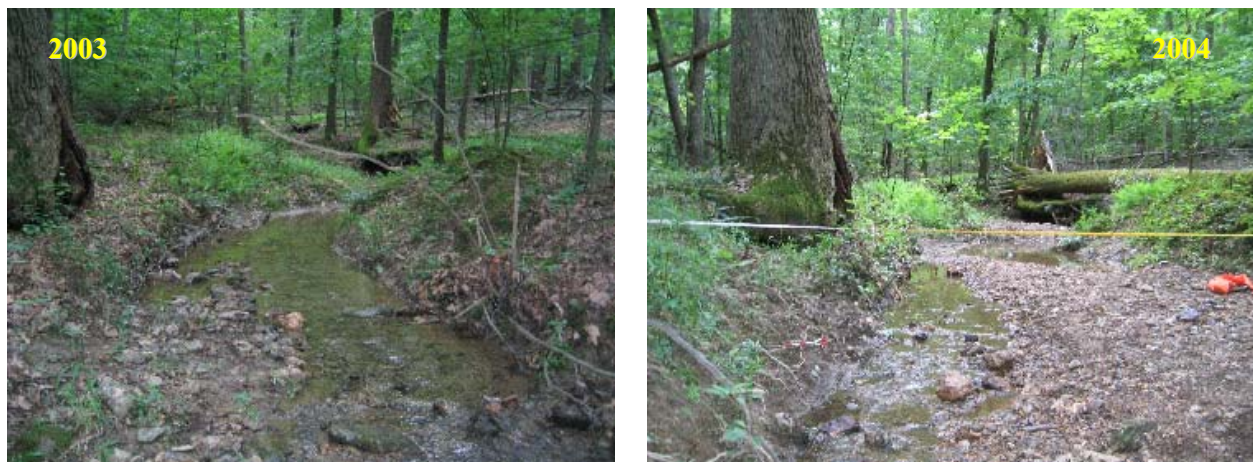
Figure III-D19: Soper's Branch (LBSB101) Sub-Area 2 Cross Section 1 - Facing Upstream in 2003 and 2004.

Photos of left-right banks and upstream-downstream were taken at each cross section of each area. In a period of 1 year, Soper's Branch has changed drastically in some of the study areas. Figure III-D19 depicts a sand bar formation, a change in which side of the channel the water flows, tree falls, and other visual changes in stream features. Over time, these photos will enable the County to pictorially document any drastic changes that may occur in the positive control, negative control, and test areas. In Figure III-D20, LSLS104 Area 4 captures how this stream has shifted to a channel that was abandoned in 2002 (right side of the photos).
